Report NOSC-N66001-82-C-0029 R

ASSESSMENT OF THE TECHNOLOGY AND PRACTICE FOR DETERMINING CASING
DEGRADATION DURING OFFSHORE DRILLING OPERATIONS

NDE Technology, Inc.
2909 Oregon Court, Suite C-8
Torrance, Ca 90503

September 1982

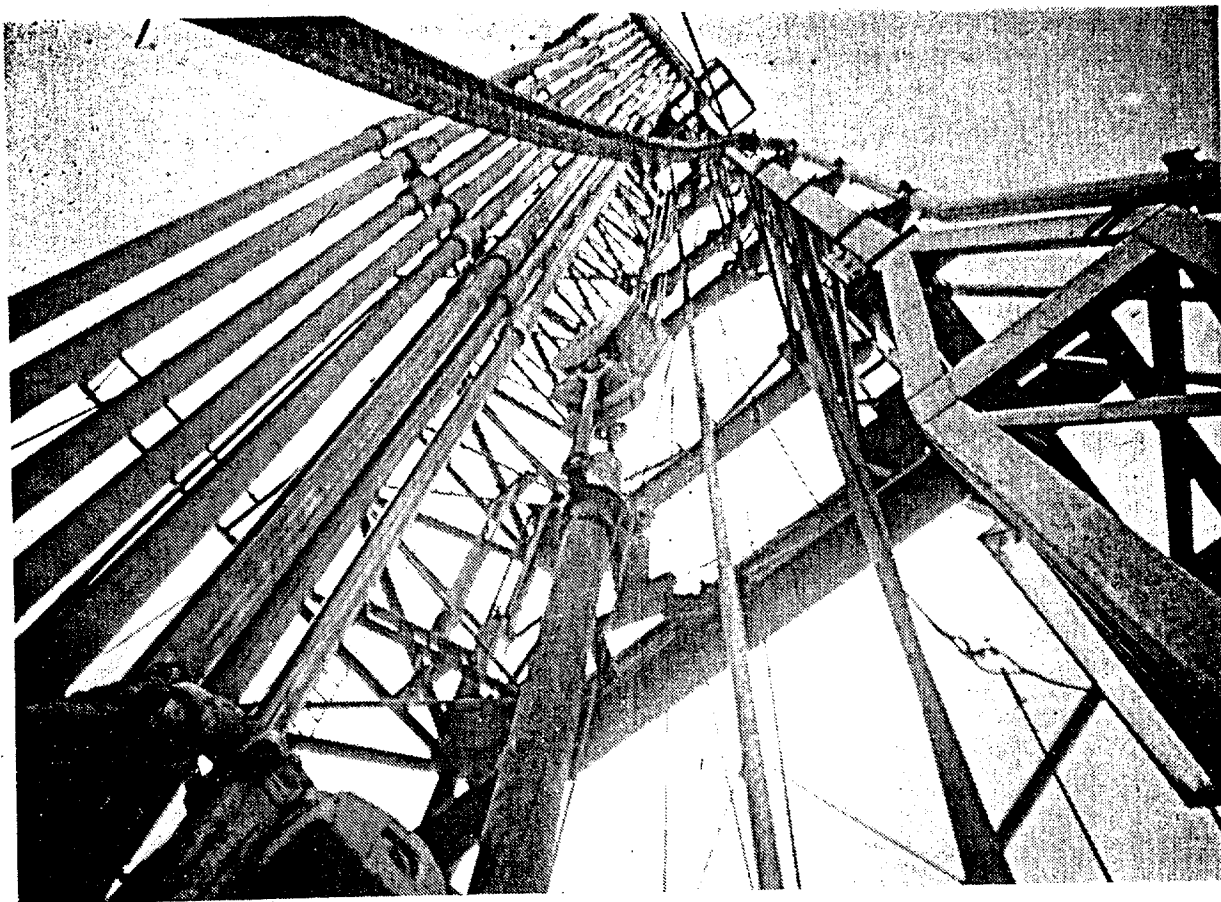
Figure 5. Procedure for salvaging bad casing out of the hole for THUMS rig T-8 at Chaffee Island, California. (Extensive drilling operations have caused this casing to become worn in vital areas.)

Casing degradation during drilling operations is due primarily to drill pipe rubbing. Examples of typical casing degradation during drilling are shown in Figures 1 through 3 for the THUMS drilling rigs located at Long Beach and Chaffee Island, California. Photographs of representative drilling operations for the drilling rig at Chaffee Island are shown in Figures 4 through 7.

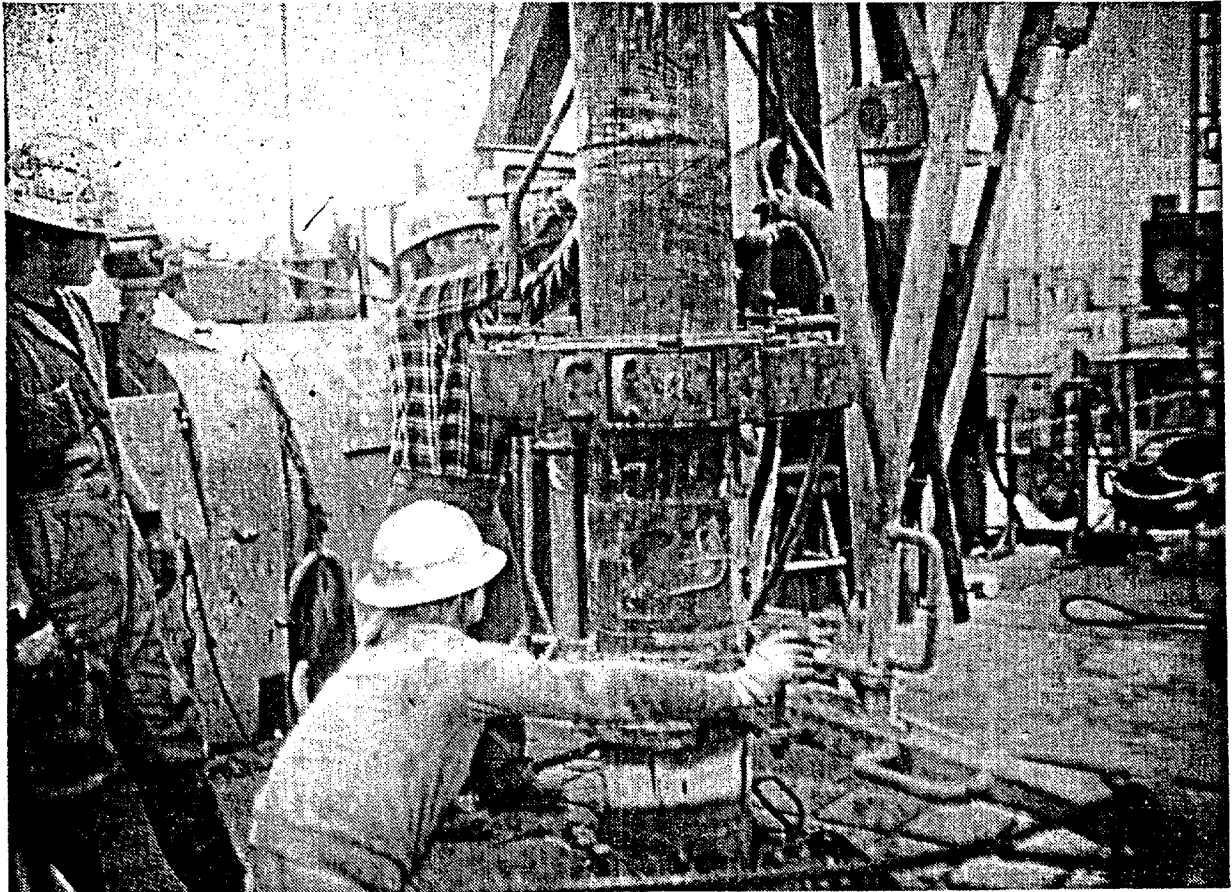
Figure 7. Installation of last casing section into the well.
(The person on the bottom left is holding manual backup tongs to keep the casing from turning; the person on the top left is using power tongs to screw the top section of casing into the bottom section.)

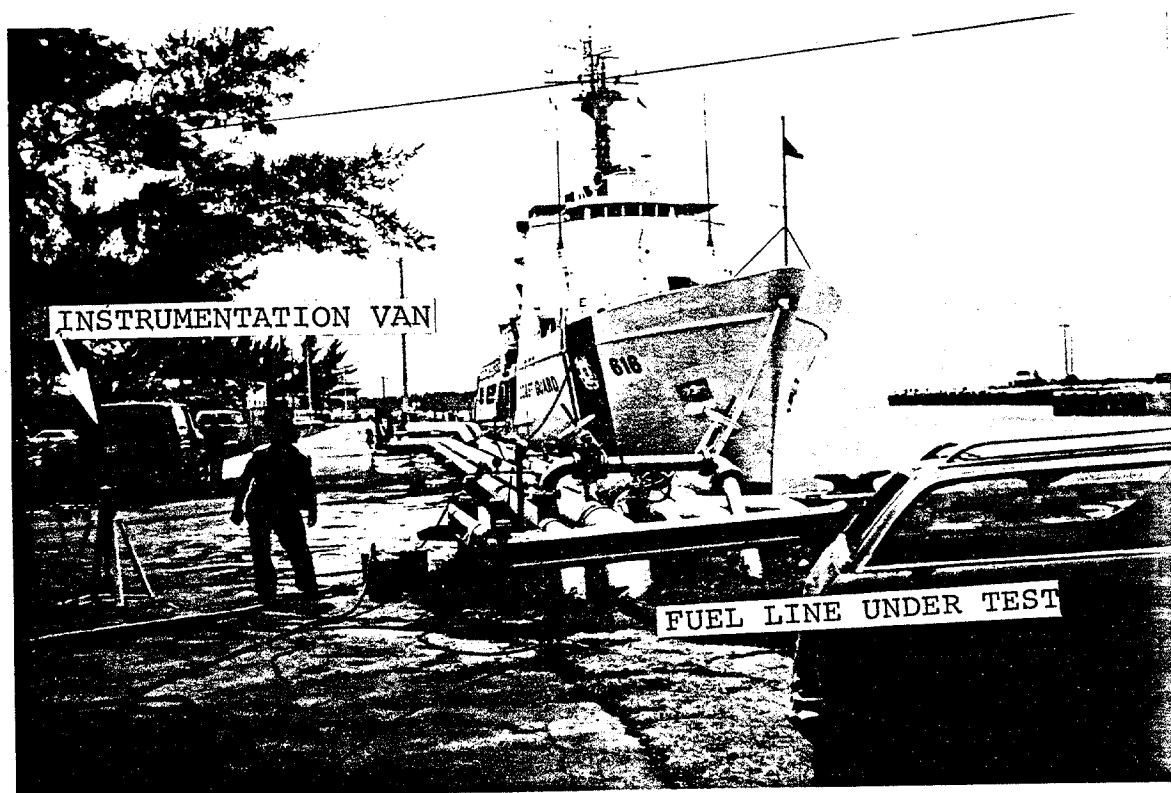
(A) TEST SETUP AT TANK FARM

(B) TEST SETUP AT FUEL PIER

Figure 18. NDE Technology, Inc. team carrying out acoustic emission/hydrostatic test of a pipeline system at an aircraft and ship fueling facility.

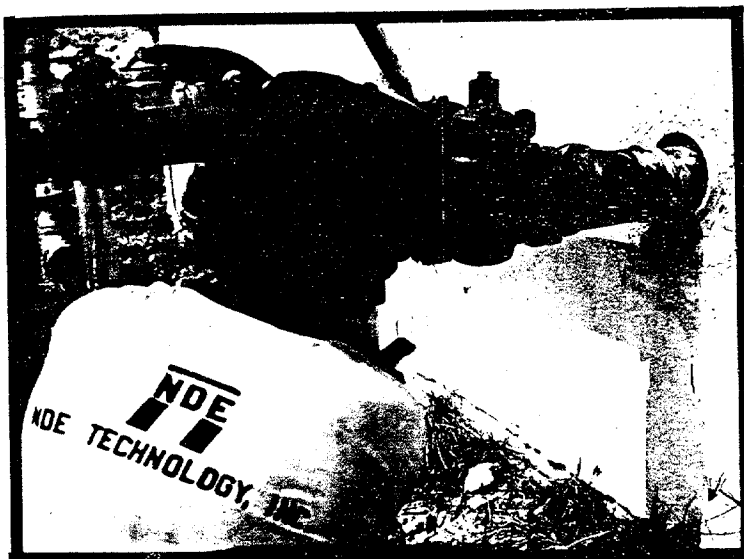
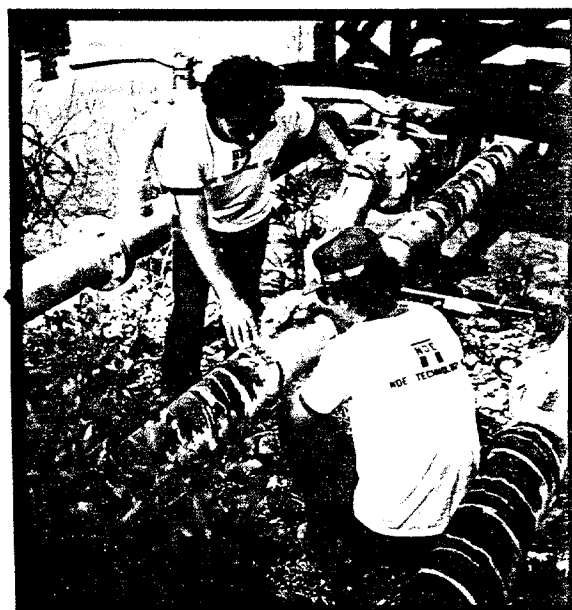
(A) LEAKING PIPE SEAM

(B) LEAKING PIPE SECTION

LEAKING SECTIONS OF PIPING SYSTEM DETECED VISUALLY AND WITH NDE TECHNOLOGY, INC. VAN-BASED ACOUSTIC SYSTEM

(C) ACOUSTIC SENSOR ON PIPE IN VALVE PIT

(D) ACOUSTIC SENSOR ON PIPING AT FUEL PIER

ACOUSTIC EMISSION INSTRUMENTATION SYSTEM AT VARIOUS LOCATIONS ON PIPELINE

Figure 19. Typical leaks and instrumentation use during acoustic emission/hydrostatic test at an aircraft and ship fueling facility.

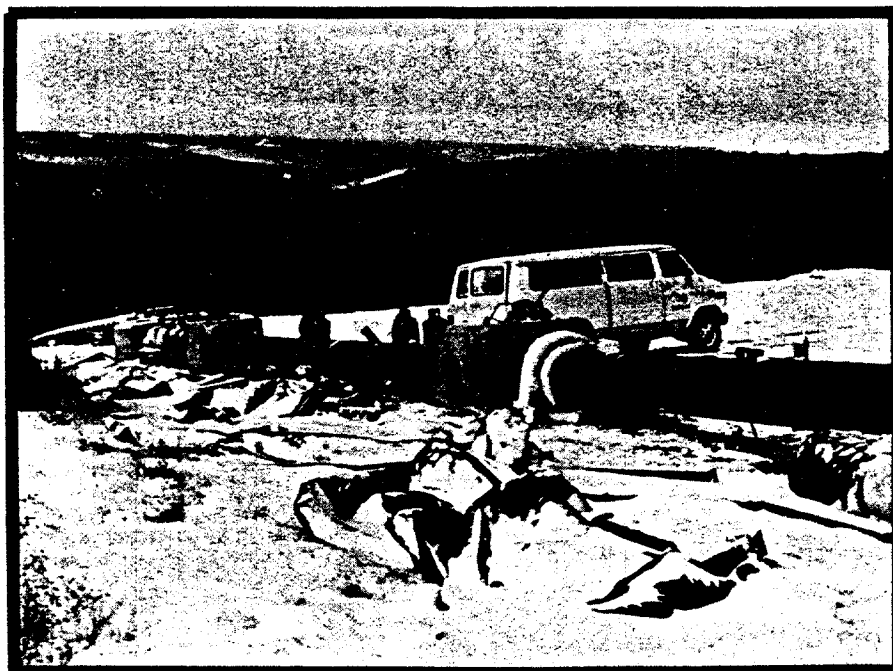
Figure 20. On a section of Alaskan oil pipeline, a van-based system performs acoustic emission source-location test for flaws.

The acoustic emission systems use acoustic sensors to detect the acoustic signal generated at the defect or leak of the component tested. External impacts, excessive internal stresses from material defects and damage, precursor internal stresses just before a leak or material failure are all different; each event produces a characteristic signal that can be differentiated from each other.
